A Model for Vibration Monitoring of Immovable Art in Churches: Reflections on Monitoring as a Tool for Preventive Conservation

Anna Henningsson

During construction of a 6 km long railway tunnel close to historic churches in Stockholm, a preventive monitoring model was applied for ensembles of large-scale immovable ecclesiastical artworks. Construction work such as blasting and pile-driving took place during five years under or very close to these immovable works of art. In Sweden, risk assessment related to construction work is focused on risks associated with the building; meanwhile, there is no common approach for protecting the immovable historic works of art and architectural surfaces. This paper discusses how a preventive model for vibration monitoring on immovable artworks was developed and used as well as how the preventive purpose was perceived by different stakeholders during and after the tunnelling work. Experience from this project concludes that monitoring that includes uniform visual inspection becomes crucial for being able to protect the artworks. The concept of vibrations standards relying on fixed numbers of critical vibrations levels for mitigating the effects

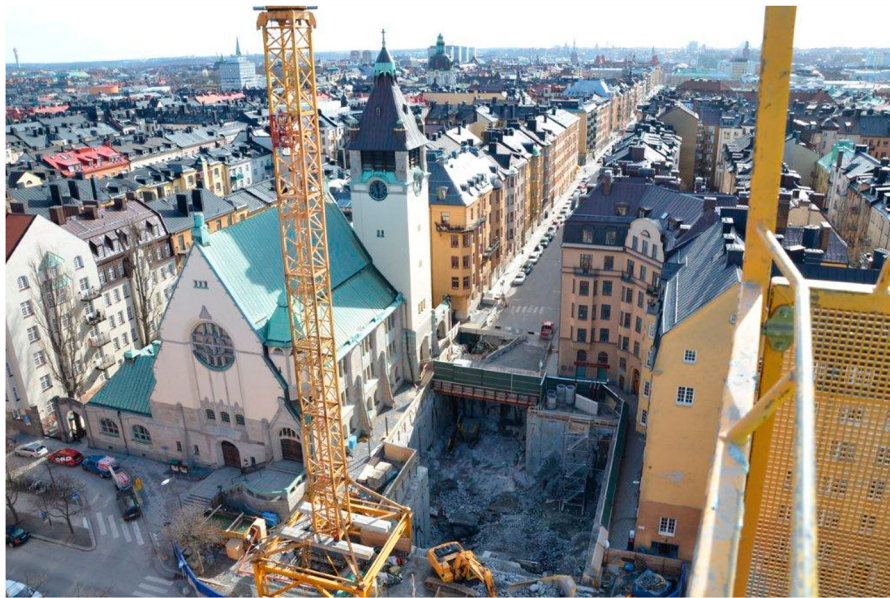
Figure 2. Construction work close to one of the churches in Stockholm during the City-Line project. Photo: Ask Lenzig.

Based on this background the City-Line project in Stockholm decided to develop a model for this tunnelling project (Figure 2) with the *aim of preventing* damage to the works of art through risk assessment and continuous monitoring of the actual response of the works of art to the tunnelling work.

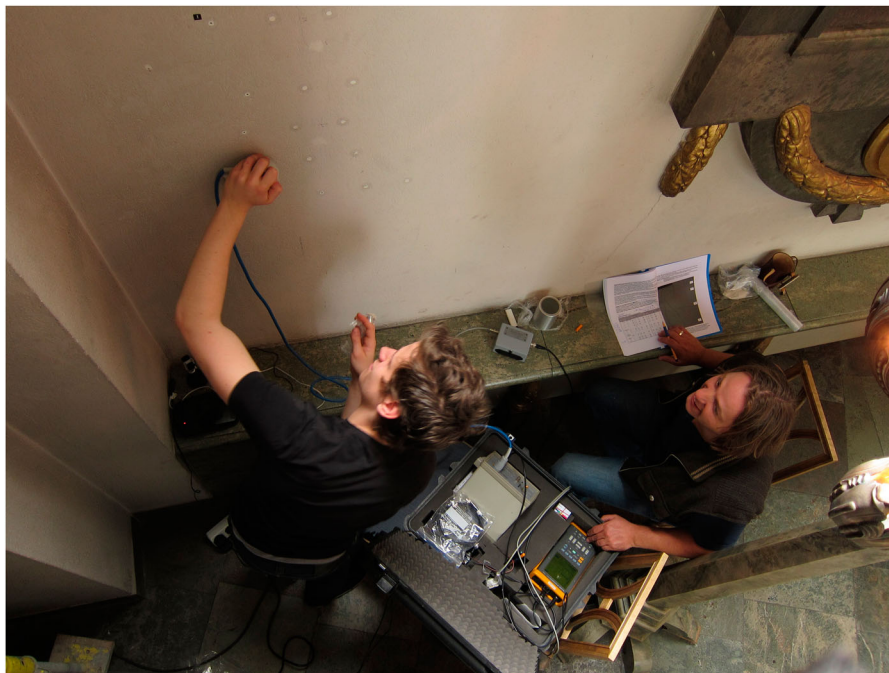
Figure 3. Ultrasonic measurement of cracks and cavities in architectural surfaces. Photo: Anna Henningsson.

materials and their response to vibrations. Ultrasonic testing was conducted to determine the condition behind the visible surface of stucco objects, and cracks in wall paintings (Figure 3). Alteration in width of cracks was measured. All of the churches were heated and in use so vibration was not the only possible agent of deterioration affecting condition.³ To be able to trace the specific impact of vibrations more selectively, the relative humidity and temperature were measured in some of the churches.

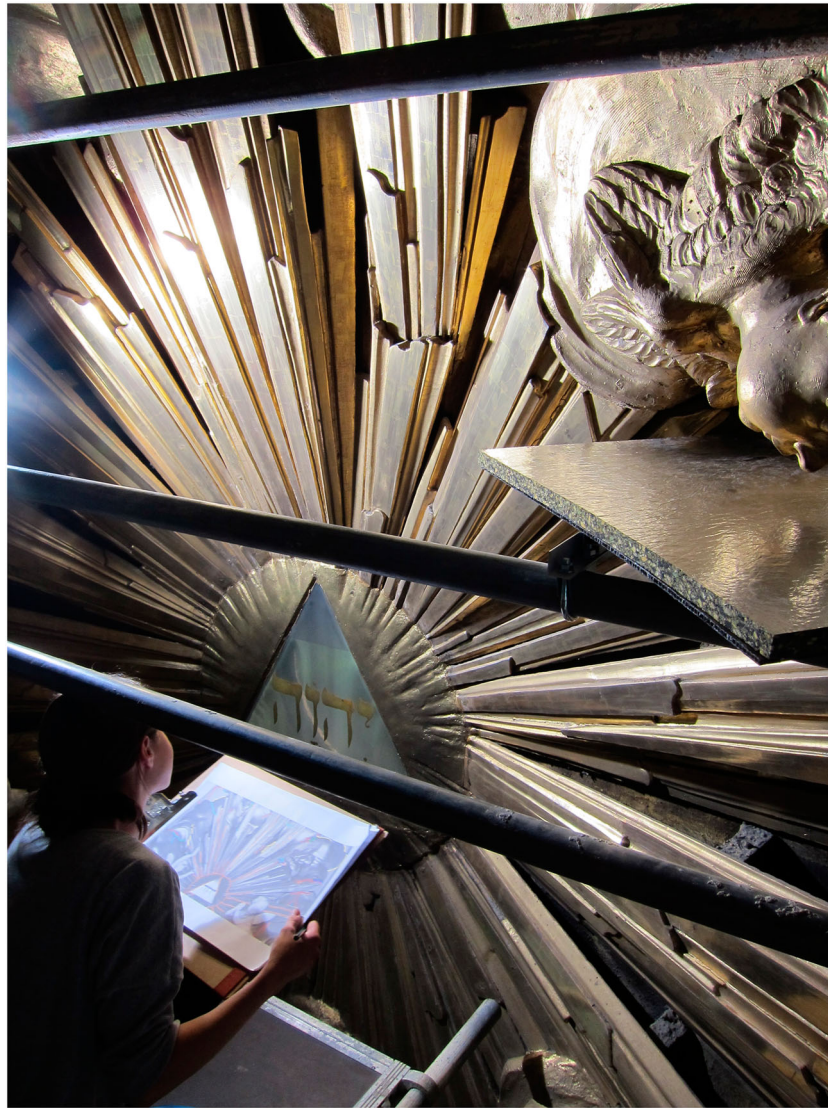
Figure 5. Visual monitoring of a sensitive portion of an altarpiece. Photo: Anna Henningsson.

Object monitoring was carried out in a uniform manner for ensuring traceability in observed changes in the artwork's materials. This meant, for example, that the lighting was always the same for each

inspection (Figure 5). Digital images were used as a basis for the visual inspection. If a visual alteration was registered on an object, a comparison with the digital *zero-point images* was undertaken *in situ* – in front of the object – by someone other than the person who first detected the change. The monitoring resulted in monthly reports for the stakeholders. The report contained the interpreted and measured vibration levels, results from visual inspections, crack measurements, and deformation measurements within the building in relation to the position of the large-scale artworks.
