Quantification, the link to relate climate-induced damage to indoor environments in historic buildings

Charlotta Bylund Melin and Mattias Legnér

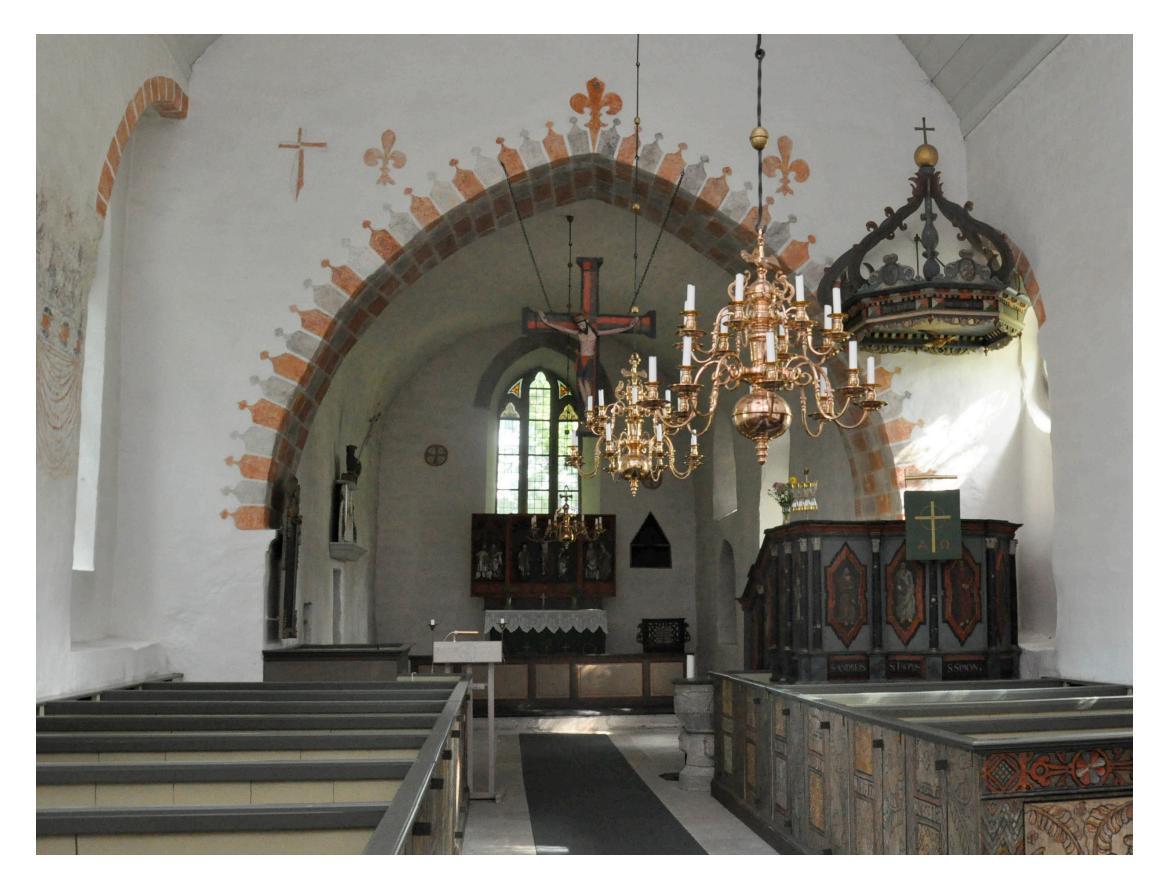
Figure 2. Interior of Buttle church with the pulpit in the south-east corner of the nave

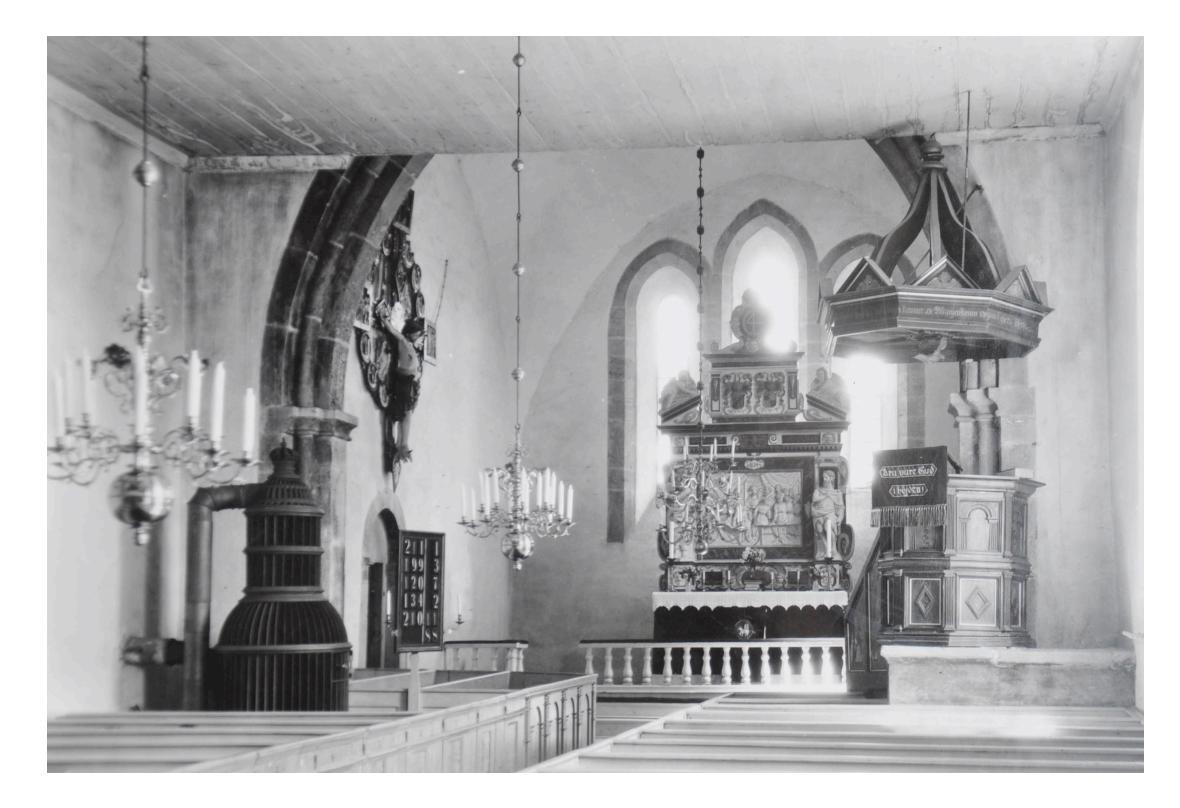
Figure 3. Fröjel church. Opposite the pulpit is a Gurney type of oven located in the north-east corner of the nave. Source: ATA, The National Heritage Board (photographer: H. Faith-Ell, 1931)

From a research perspective, the Gotland churches are a good model base for population studies. The method used for this survey was to assess damage in 16 of the 92 churches. These particular churches were selected to represent the different heating regimes used in Gotland churches. Heating of the nave was first introduced in rural Gotland churches around 1900. The oldest kind of heat source was the Gurney's oven (Figure 3).

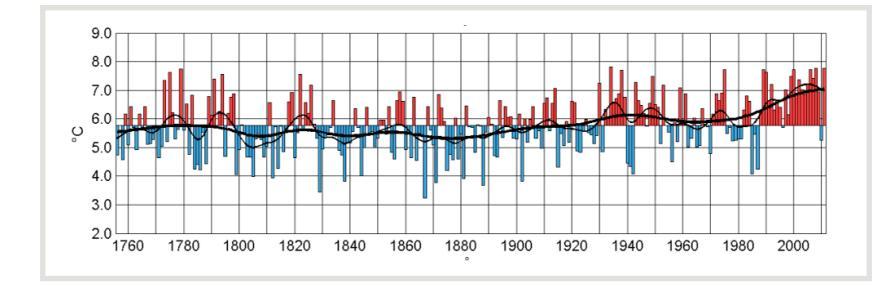
Figure 4.

Annual average temperature of Stockholm 1756– 2011 (reconstructed data). Source: SMHI (www.smhi.se)

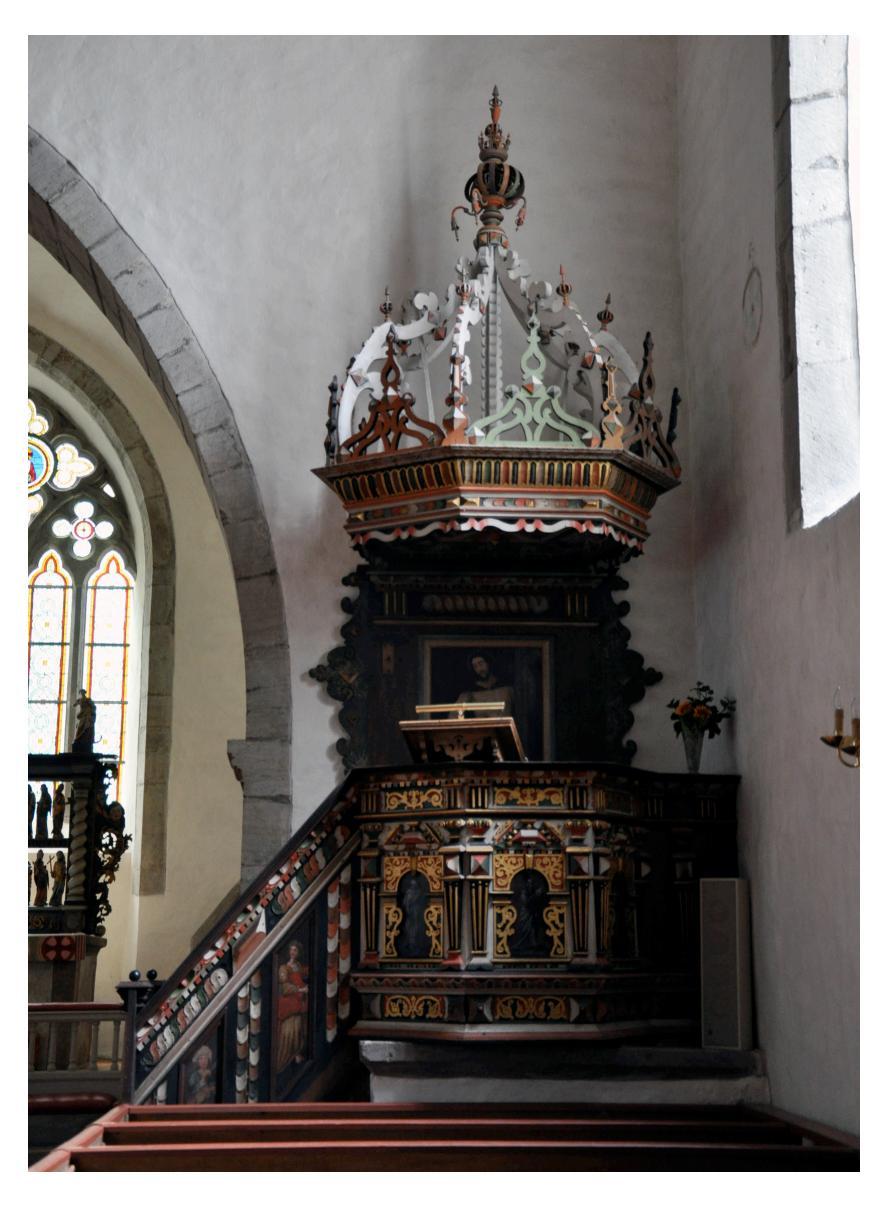
Figure 5. The pulpit in Hörsne church

The objects chosen for the survey were pulpits (Figure 5). They are commonly found in the churches and on Gotland they are made of local wood (normally pine). They were originally painted polychrome using oil paint [7]. In the majority of the churches they are located in their original positions e.g., the south-east corner of the nave, and have only on rare occasions been moved. The pulpits are fully or partly freestanding, avoiding microclimate conditions which can develop around objects in close contact with an exterior wall.

The pulpits consist of interlinking wooden elements, which can become visibly deformed as the elements can act as restraints on each other. Visible signs of mechanical deformation are cracks, open joints and shrinkage, as revealed by unpainted edges where the wooden elements overlap.

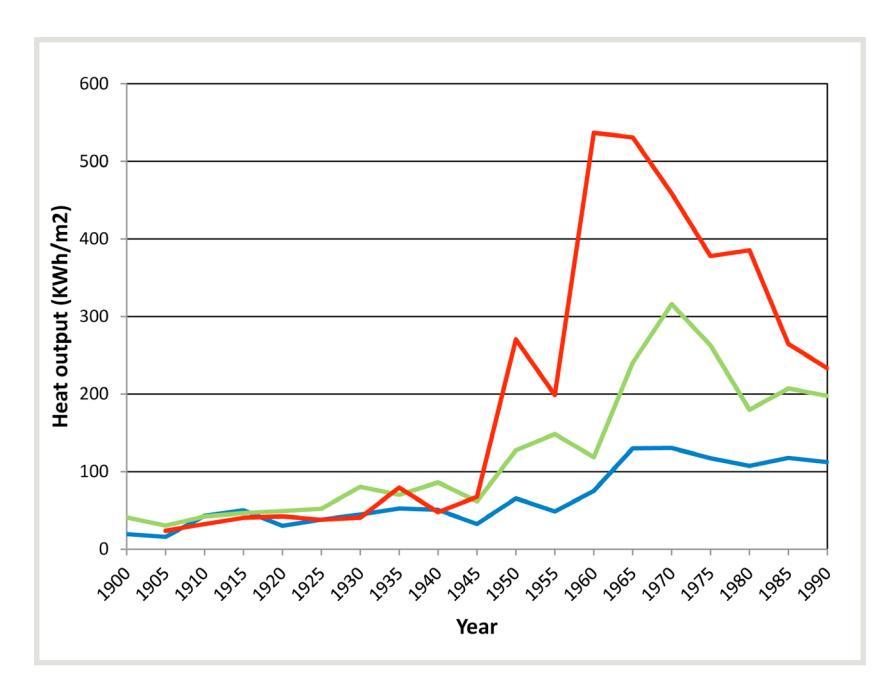
Figure 6. The heat output for every fifth year in the 16 Gotland churches, 1900-1990. The red curve is the average values of the churches with high total heat output $(> 15 \text{ MWh/m}^2)$ the green curve is the average of the churches with medium heat output $(8-15 \text{ MWh/m}^2)$ and the blue curve low heat output $(< 8 MWh/m^{2}).$ according to table 1

Today, all churches are heated intermittently but there was no RH control in any of them before the 1990s. Data on background heating, used in 11 of the 16 churches, was obtained from the parishes. The other five churches are allowed to cool down between the sermons. A sudden rise in heat output (Figure 6) indicates a drastic change of the heating regime, for example the introduction of background heating, or it could relate to one or several extremely cold winters. As seen in figure 4, the winters of the 1910s and 1920s were unusually cold, and the winters during World War II (when churches were rarely heated) were very cold. There were also a few very cold winters in the mid-1980s. On the other hand, a considerable drop in energy output would indicate a shift in heating regime or one or more mild winters.

It has been shown that the degree of heating in churches has varied over time, and that these variations can be tracked by using archival sources. This means that it is not necessary to speculate how a particular church was heated in the past. Figure 6 shows the fluctuation in heat output for each five-year interval in the 16 churches. The general tendency is that there was a low and stable heat output during the first half of the century. After World War II there was a strong increase in heat output. It is also noticeable that the larger the total heat output, the larger the fluctuations. Table 1 shows that there is a relationship between present background heating and total heat output, e.g., churches without background heating generally show low heat output. The damage as an individual parameter or in combination was related to indoor climate variables as seen in table 2. It is known that permanent heating in historic buildings has caused incalculable damage to painted wooded objects [21] if the relative humidity is not controlled.

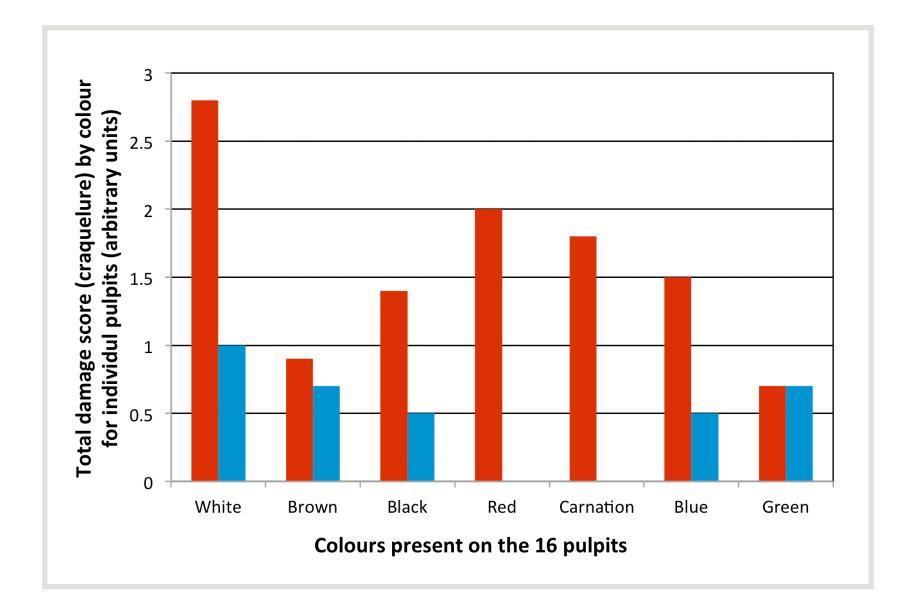
Figure 7. The relation between damage score of the different colours on the pulpits in the 16 churches with and without background heating. For all colours, except green, there are more craquelures (higher damage score) in churches with background heating (red bars) compared to churches without (blue bars). For red and carnation colours there are no craquelures in churches without background heating and hence no blue bars in the diagram

When the different background heating temperatures were compared (5 to 12 °C) with the condition of the pulpits it had been assumed that higher temperatures would cause more damage. No relationship was identified, however. By dividing the churches into two simple groups, those with and without background heating, a clearer pattern emerged; more damage craquelures were observed in churches with background heating (Figure 7).

This tendency was clear for all colours, except green, on all pulpits. Making the same type of comparison between the different colours and the total heat output did not show the same relationship. However, a comparison of the three levels of total heat output with the total damage scores for all craquelures of all colours for each pulpit showed lower damage scores in churches with lower heat output when compared with those with medium heat output (Figure 8). The same relationship is also found in churches with and without background heating. There is also an increased frequency of paint delamination in churches with background heating.

Type of damage (indoor climate indicator)	The relationship between churches with and without background heating and damage	Relation between the total heat output (MWh/m²) 1900–1990 and damage
Mould	Mould is more frequent in churches with background heating	None
Flight holes	Flight holes are more frequent in churches without background heating	None
Mould + flight holes	None	None
Cracks in wood	None	None
Open joints	None	None
Cracks + open joints	None	None
Paint delamination	Paint delamination is more frequent in churches with background heating	None
Craquelures (aging)	Slight correlation. Less damage in churches without background heating	None
Craquelures (drying)	None	None
Craquelures (aging + drying)	Yes, less amount craquelures in churches without background heating (Figure 7)	Yes, less craquelures in churches with the least heat output (Figure 8)

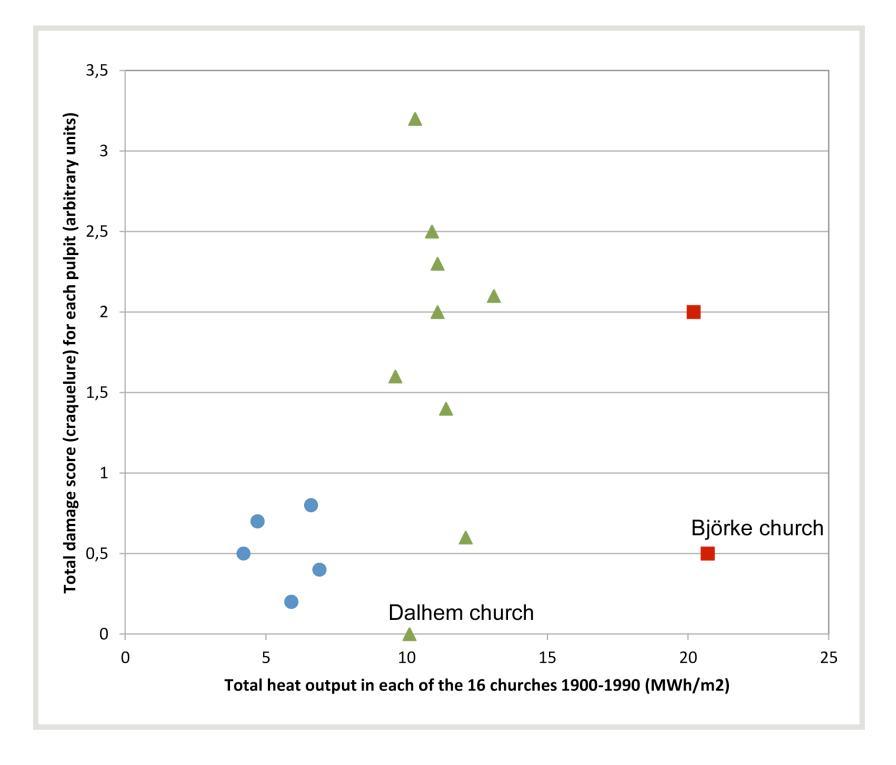
Figure 8. The relation between the total heat output (MWh/m²) and total damage score for craquelures of all colours of each pulpit in each church. The group of red squares are the damage scores from pulpits in churches with high heat output as presented in table 1 (> 15 MWh/m²). Green triangles are pulpits representing medium heat output (8 to 15MWh/m²) and blue circles are low heat output (< 8 MWh/m²). The two outliers, Dalhem and Björke churches showing low damage scores have pulpits which were repainted by the same painter, C. W. Pettersson, as late as the beginning of the twentieth century and therefore craquelures may not yet have developed
